Non-Destructive Field Tests in Stone Conservation

Field and Laboratory Tests

Rapport från Riksantikvarieämbetet 2006:4

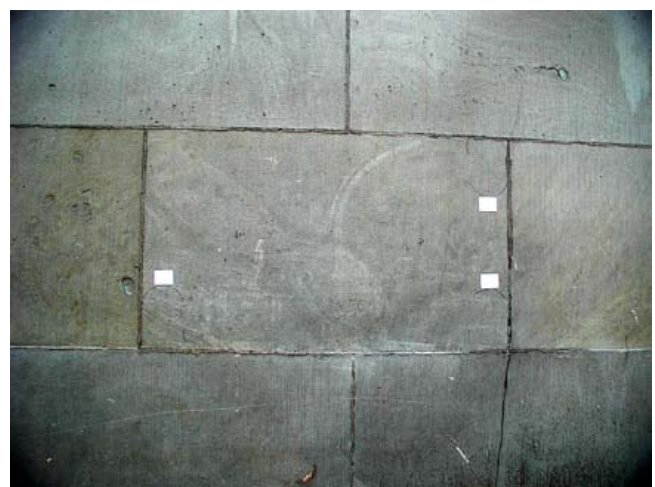
Figure 1. Labels attached for the granular disintegration test.

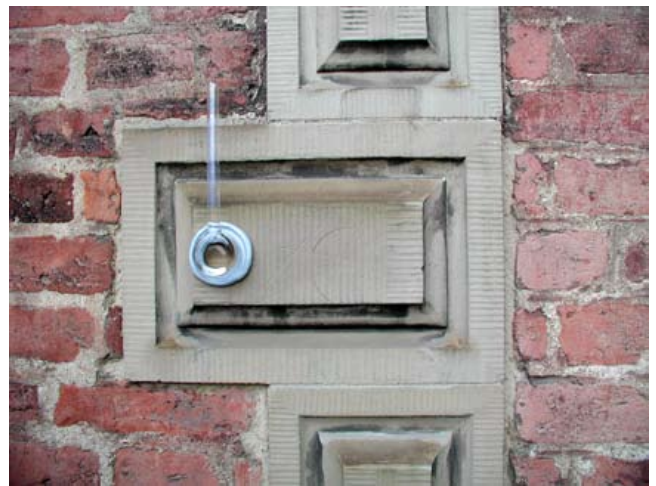
Figure 2. Measurement with Karsten pipe at Riddarhuset.

The pipe is attached to the stone in such a way that it will stick for at least an hour. It is important that the sticky gum doesn't spread into the body volume in such a way that it diminishes the contact area of the water. The pipe is then filled with distilled water until it reaches 4 or 10 ml. The measurements are made according to prefixed time-schedule: after 1 minute it is noted how much water has been absorbed and the same procedure is repeated every minute until 5 minutes have passed and hereafter is every 5th minute noted until 30 minutes have passed and thereafter every 10th minute until 60 min have passed.

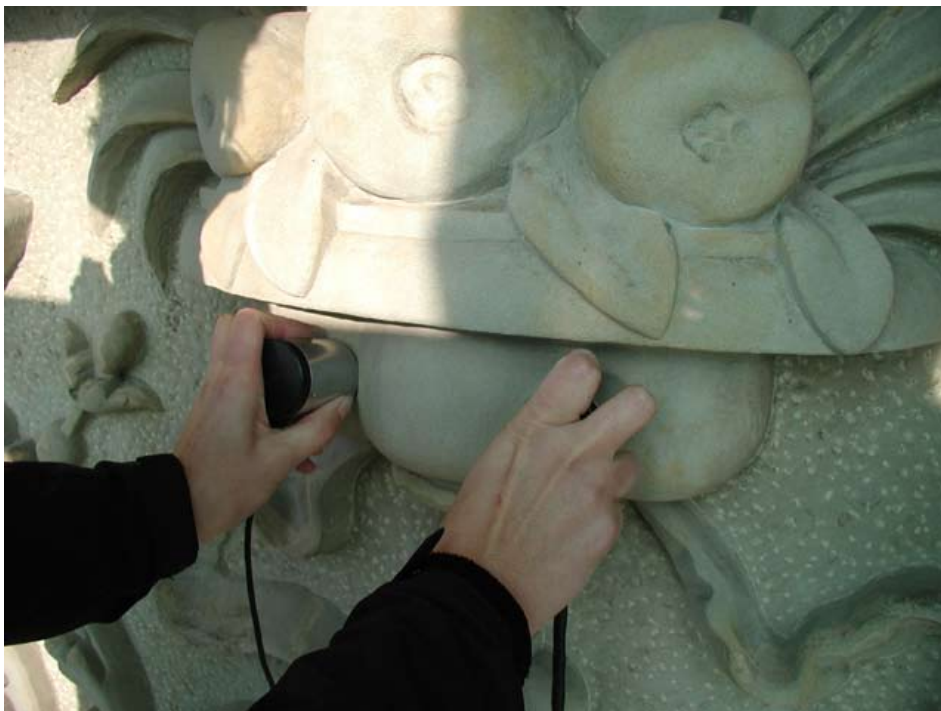
Figure 3. Ultrasonic measurements undertaken at the German Church.

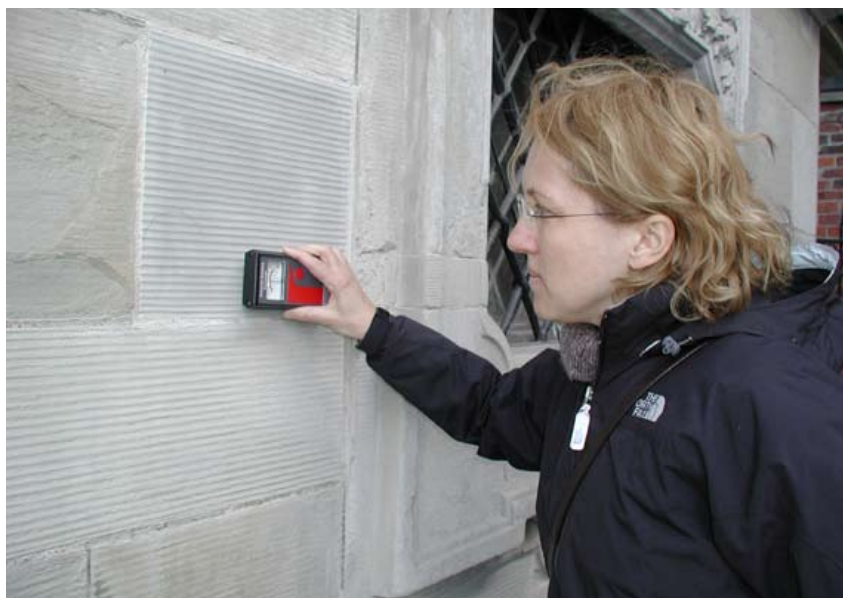
Figure 4. Moisture measurement with a Tramex at Karolin Chapel.

Resistivity methods are carried out by measuring the resistance between two electrodes that have been tapped into the material. The measurement is based on the principle that the electrical resistance decreases when moisture is present in a material. The measurement is compared with a calibrated curve for the specific material. This, together with measurement of the temperature makes it possible to measure the moisture content by mass (u).

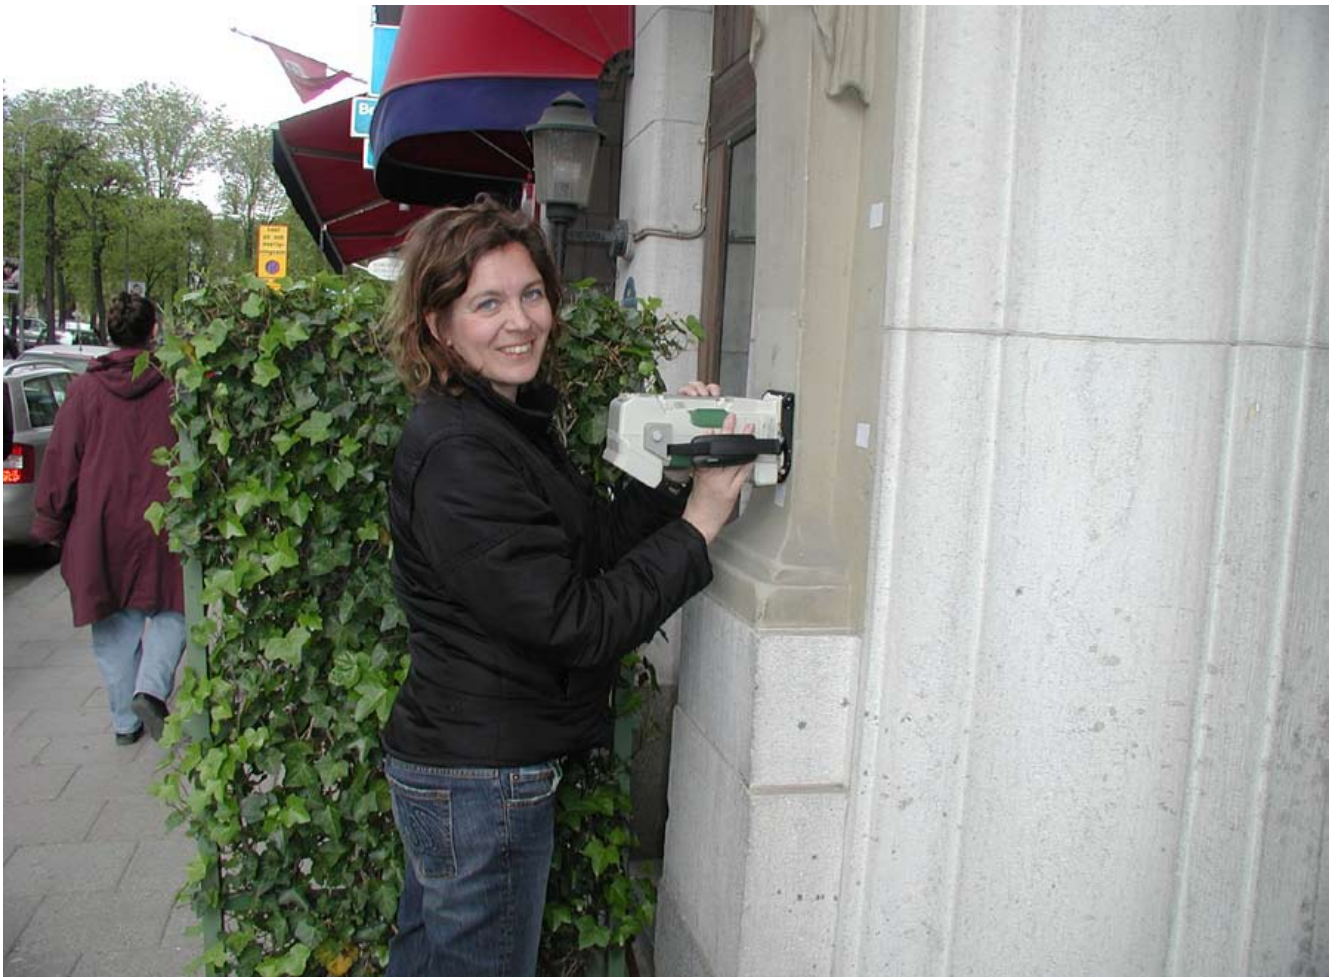
Figure 5. Colour measurements using a Minolta CM-508i at Narvavägen 30.

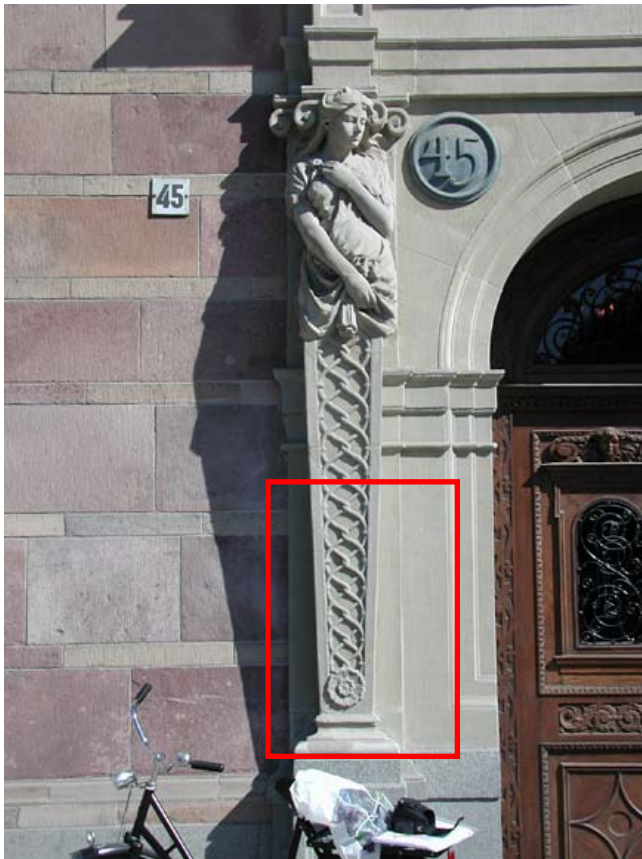
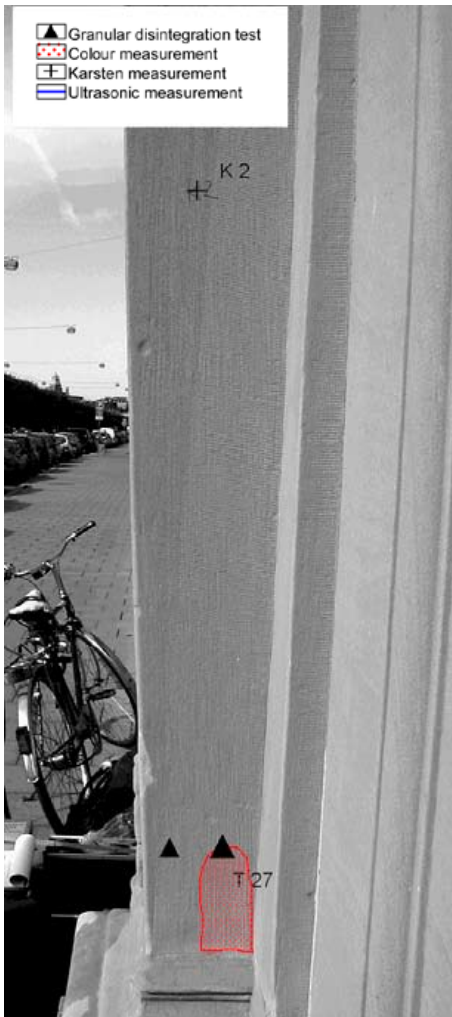
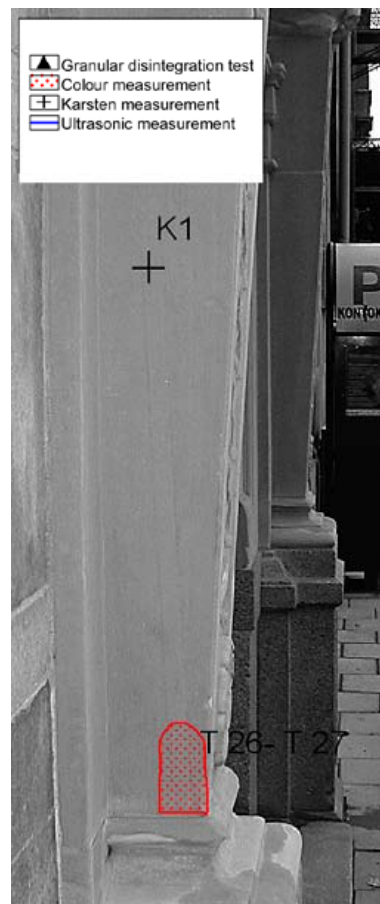
The portal is situated on the south side of the building in direct sunlight. The chosen area of investigation is on the left side of the portal. The stone is in good condition, with an even grey colour and no black crust or granular disintegration or biological growth. The ornamented front piece is somewhat yellowish in colour. The colour may be the remains of an oil treatment.

Figure 7-10. The chosen area of investigation at Strandvägen 45.

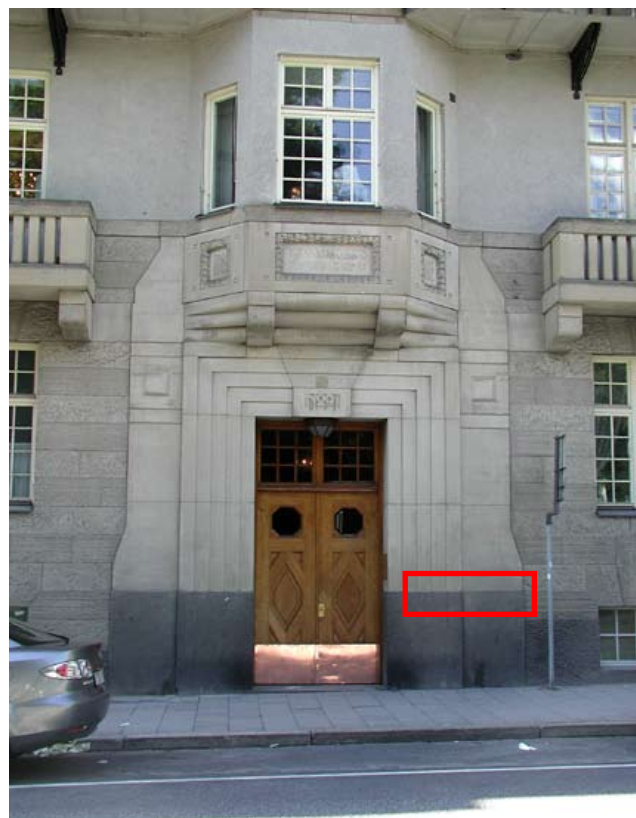
Figure 17–18. The chosen area of investigation at Engelbrektsgatan 21.

Apart from being rather dirty the stone is in good shape, and no biological growth or black crusts are evident. The surface has a "fat" texture – as though it has been treated with water repellent. This could be an anti-graffiti treatment. Vestiges of white oil paint can be seen on the surface.

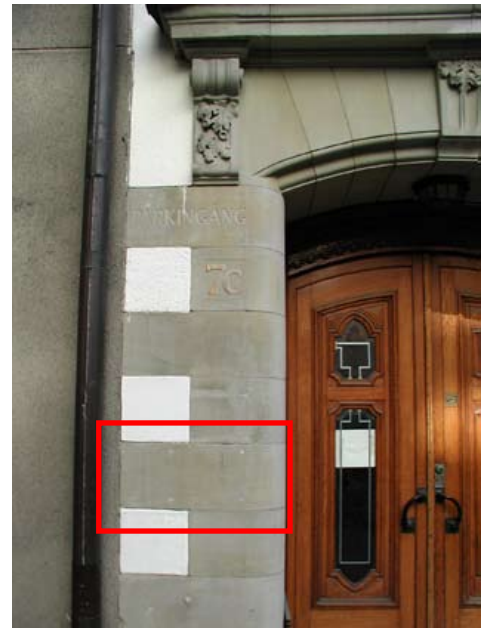
The Gotland sandstone portal at Strandvägen 7 C is included in the Diplomat Hotel complex. The house was erected in 1907 and was designed by architect V. Bodin. The investigated Gotland sandstone portal is to be found in the inner courtyard. The left side of the portal was investigated. The conservation history is unknown. The Gotland sandstone is in good condition and there is no biological growth or granular disintegration or exfoliation. However, the original chiselling was damaged by an earlier treatment; probably cleaning with abrasives.

Figure 19-21. The chosen area of investigation at Strandvägen 7C.

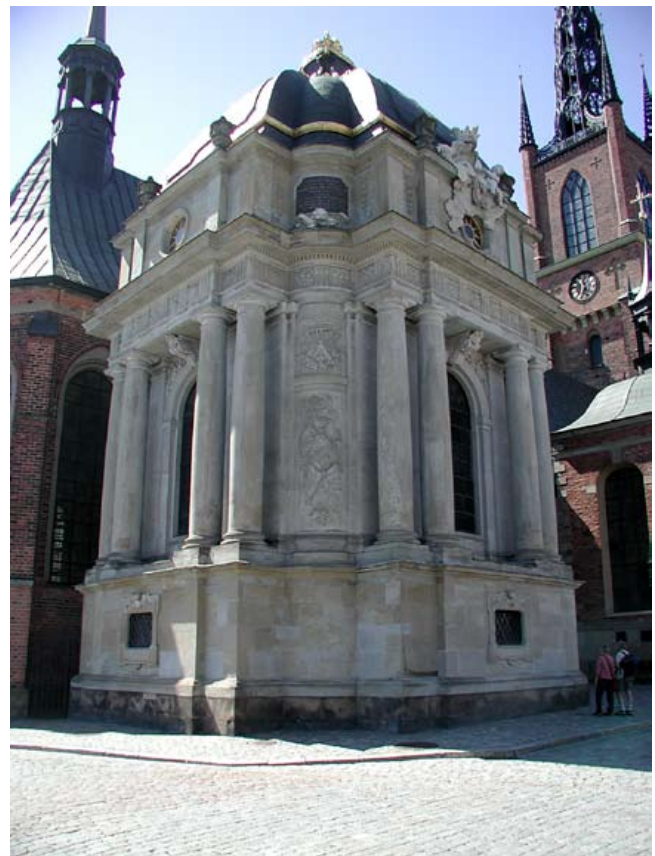
Figure 22–23. The chosen area of investigation at the Karolin Memorial Chapel.

The Karolin Chapel is constructed in Gotland sandstone (ashlar stone) deriving from different periods and in various states of conservation. The chapel was painted right from the very beginning, although all the original paint has since been removed. The chosen area for investigation is found in the niche heading northwest. The investigated area consists of at least three kinds of stone: 1) Gotland sandstone in yellowish colour. The yellow colour probably derives from a previous oil treatment. This stone is weathered and subjected to some granular disintegration, but has no black crusts and no biological growth. 2) Light yellowish sandstone. The stone presents exfoliation and some granular disintegration, although no biological growth or black crusts. 3) New light grey chiselled stone. The stone was inserted in 1989–1992

by Slite Stenhuggeri. This stone is clean and has no granular disintegration, biological growth or black crusts.

Three kinds of stone were investigated; one new inserted stone from 1992 (type 3), one yellowish stone that probably dates from the 18th century (type 1) and an ornamental window frame from the 17th century (type 2).

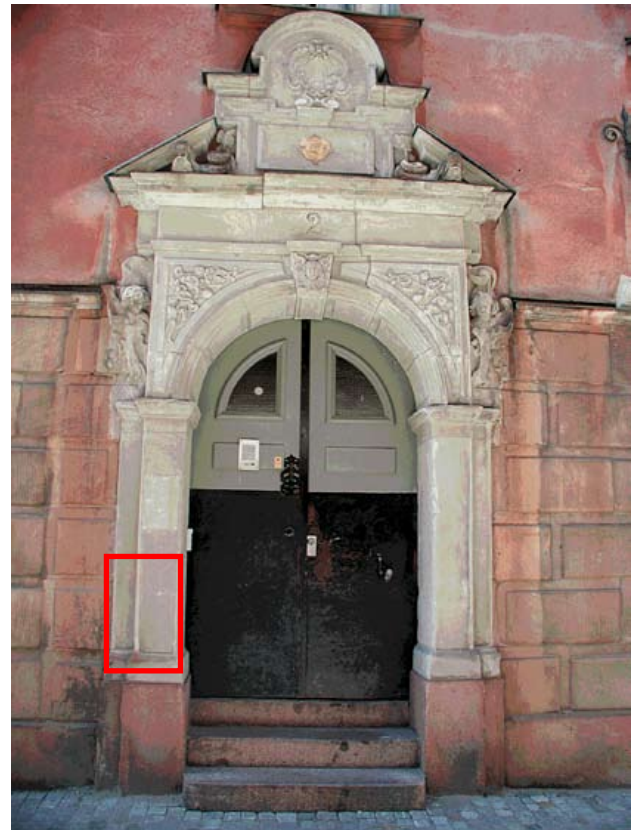
Figure 29–31. The chosen areas of investigation at Lilla Nygatan 2.

were replaced. The cleaning salts were then extracted – three to five times – with paper pulp compresses. A hydraulic mortar was used for the re-pointing, while Billy’s restoration mortar was used for the reconstructions. Finally, the portal was consolidated with Wacker Steinfestiger OH (52 l). The investigated area is on the left side of the portal. The stone appears to be in a stable condition, and there is no evidence of granular disintegration, biological growth, black crusts or exfoliation.

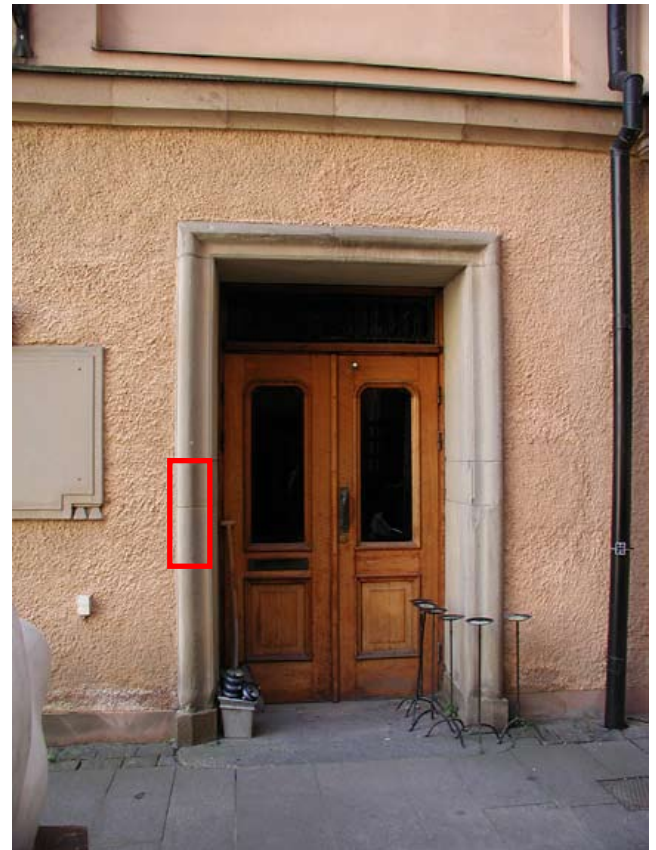
The house at Slottsbacken 2 dates from the 18th century and has been restored many times. The chosen portal in Gotland sandstone is found inside the courtyard and the investigation area is found on the left side of the portal. The conservation history is unknown. However, one can see that the stone has been cleaned with abrasives and that the treatment has damaged the stone. While the stone is subjected to heavy granular disintegration and the surface is dirty, there is no biological growth. The stone closest to the ground has serious problems caused by salt and rising damp, which provoke exfoliation and spalling. The bedding planes are vertical.

Figure 34–35. The investigated portal at Slottsbacken 2.

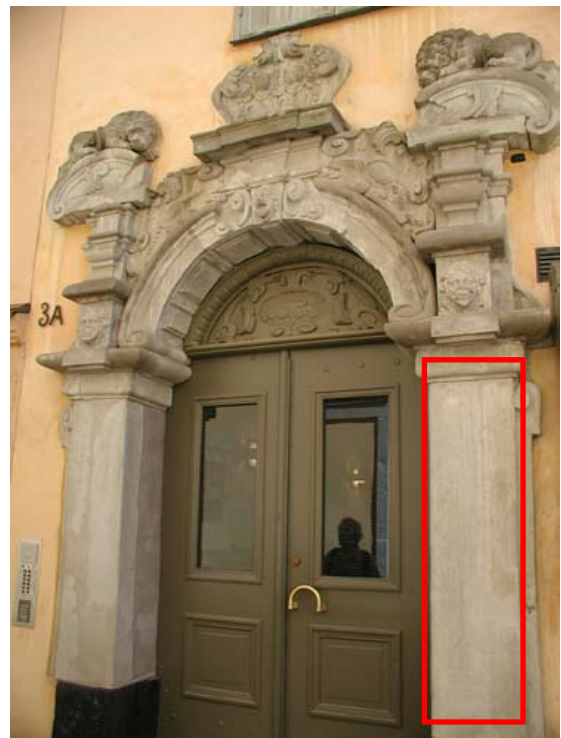
Figure 36–38. The chosen area of investigation at Bollhusgränd 3.

The decorative Gotland sandstone portal at Bollhusgränd 3 A was erected in 1635. The stone was originally painted. The builder of the house and his wife, Peter Banér and Heblbla Flemming, are commemorated in that their heraldic emblem is carved on top of the portal. The portal seems to have been constructed using old portals – or it might also be the result of a renovation in the 18th century. The appearance is thus slightly inhomogeneous. The portal has been restored several times; in 1971 by Augusto Conte (it is unknown how), and in 1992 by Prolithos and Leszek Zarzewski. The portal was found to be dirty, with black crusts, algae, material losses, cracks, old failing repairs and demonstrating salt problems. The state of conservation was described as "critical". The conservation included pre-consolidation, fixing of loose stones, cleaning with water, brushes and scalpels (in such a way that the paint remains should be left). The cleaning results were not satisfactory, however, and the conservator changed method, this time using compresses with ammonium hydrogen carbonate in bentonite clay, sand and cellstoffs and micro-abrasive cleaning (aluminium oxide

powder). Most of the older repairs were removed, salts were extracted with paper pulp compresses, the consolidation was made with Wacker Steinfestiger OH (30 kg) and, finally, the portal was treated with an antibiological treatment (1 percent Bradophen). Quite a lot of the reconstruction was done using Billy's restoration mortar. The chosen area of investigation is on the right side of the portal. Today many of the reconstructions need attention, although the sandstone is stable and has no biological growth, black crusts or granular disintegration.

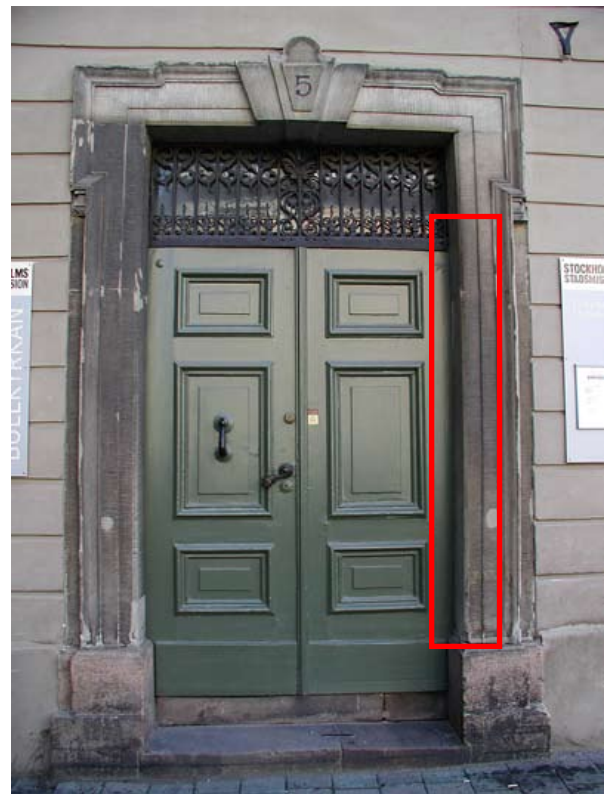
The house at Stortorget 5 was erected during the 18th century and the Gotland sandstone portal probably derives from the same period. The style is classical. The conservation history is unknown. The right side of the portal was chosen for investigation. The sandstone is very dirty – almost black, and has a black crust. The surface has a fat/waxy feel to it. There is no biological growth or granular disintegration. The bedding planes are vertical.

Figure 39-41. The chosen area of investigation at Stortorget 5.

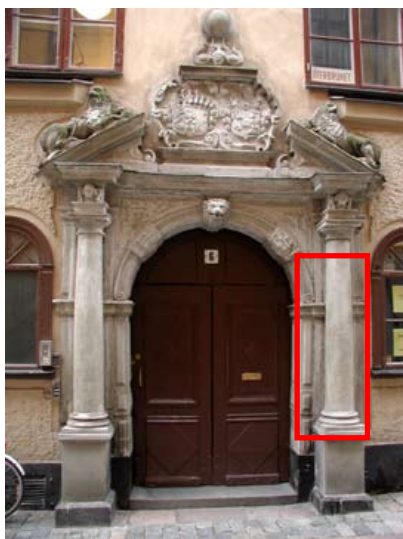
The portal is found in a house that hosts a school on a narrow street with a lot of movement. The portal is thus in danger, since many people go through the portal every day (humans, cars and bicycles pass close by). The sandstone is in a stable condition, but has an uneven colour. The stone was probably damaged during a previous treatment. There is no biological growth, black crusts or granular disintegration. The bedding planes on the column are vertical but the bedding planes on other stones could not be examined.

Figure 42–43. The chosen area of investigation at Svartmangatan 6.

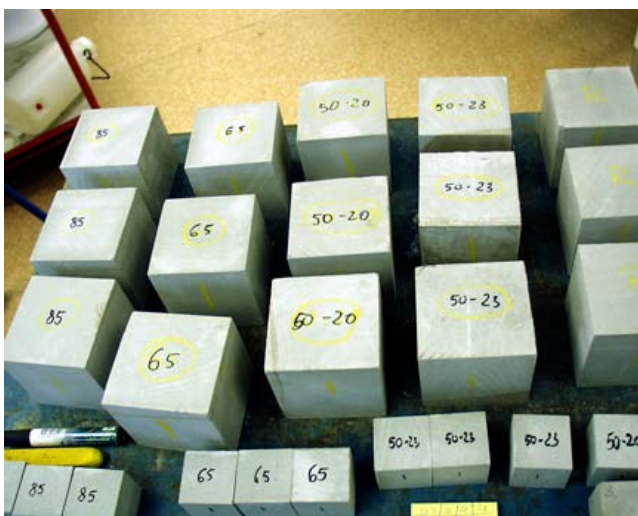
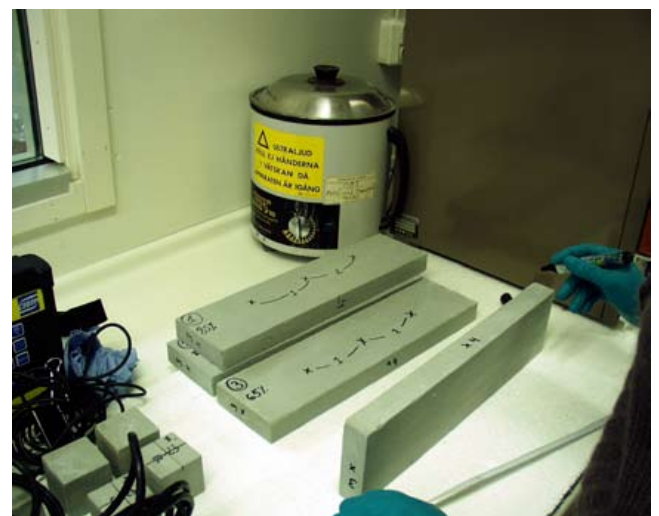
Figure 1: Samples used for the UPV analyses. Markings on the samples indicate the relative humidity.

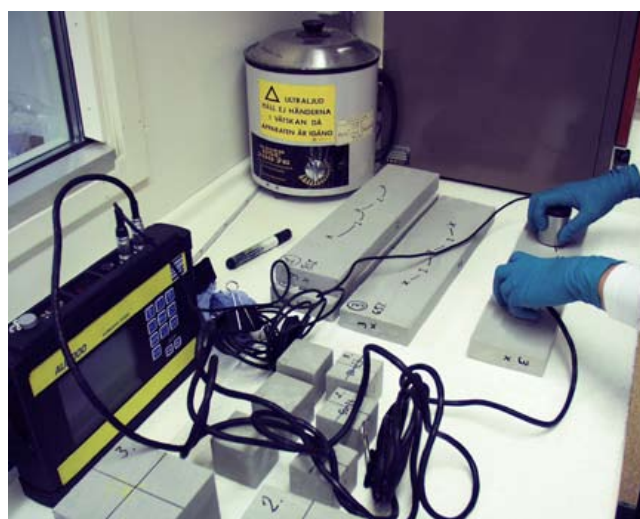
Figure 3: Indirect measurement of UPV.

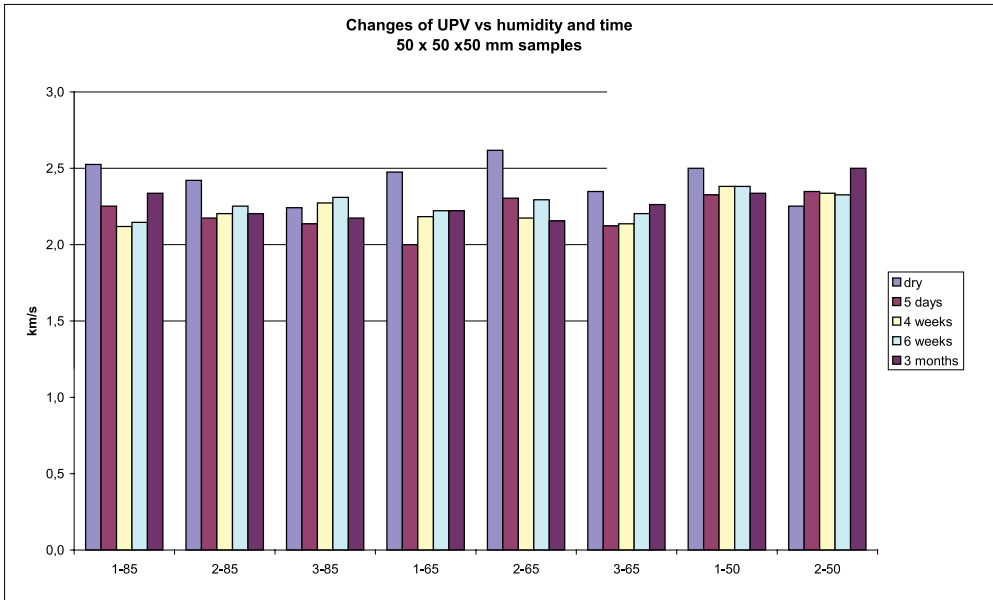
Figure 4: Changes of UPV from dry conditions (blue bars) to humid conditions. Samples 50x50x50 mm. The exposure time was 3 months and the measurements were taken 5 times, including the dry conditions.

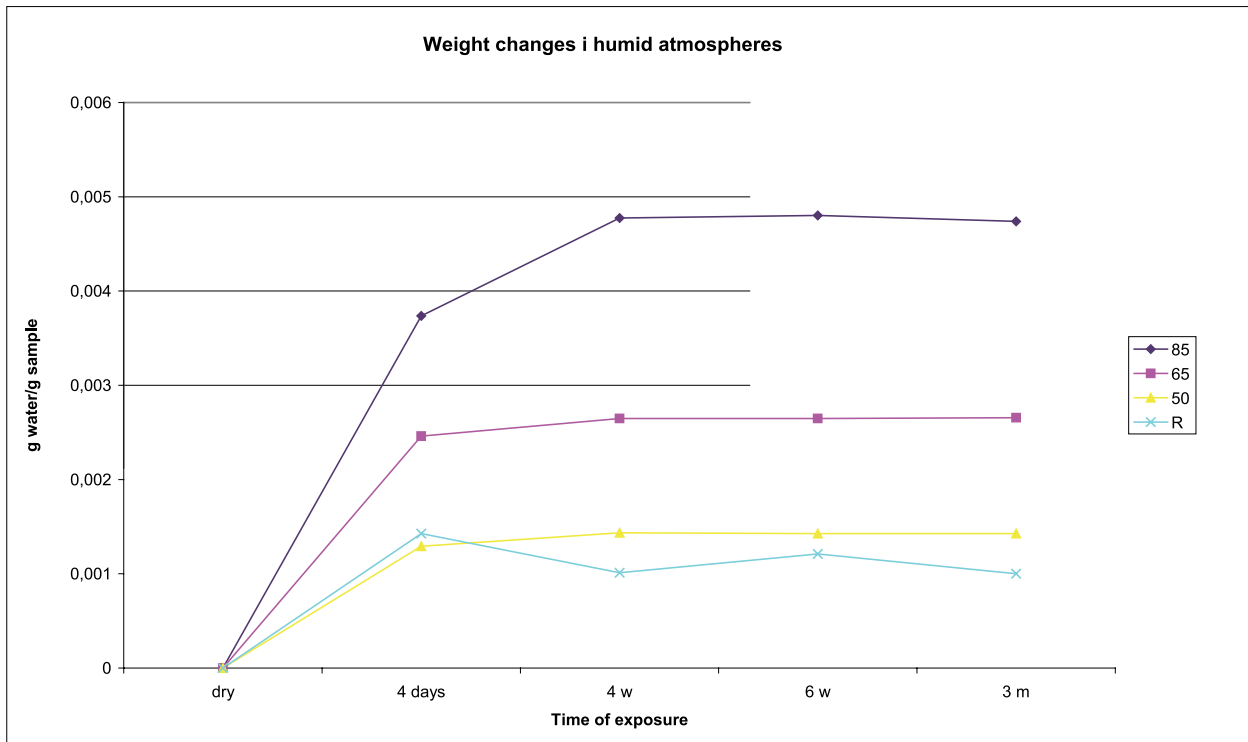
Figure 6: Weight increases for samples exposed to different relative humidities. The relative humidity varied from 0 to 85%. Time of exposure was 3 months.
